FEATURE OF PRODUCTS

REPLACEMENT OF TIMING CHAINS, SPROCKETS AND TENSIONERS

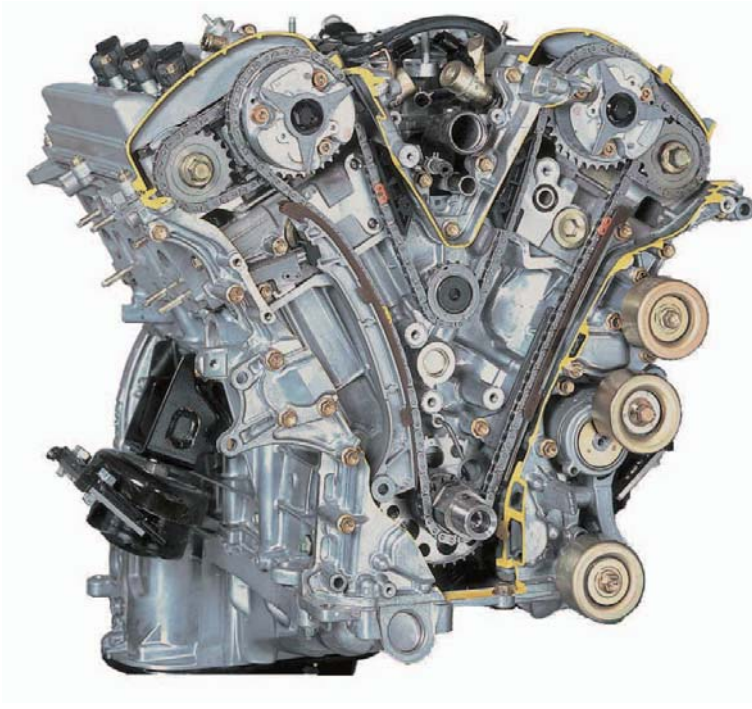
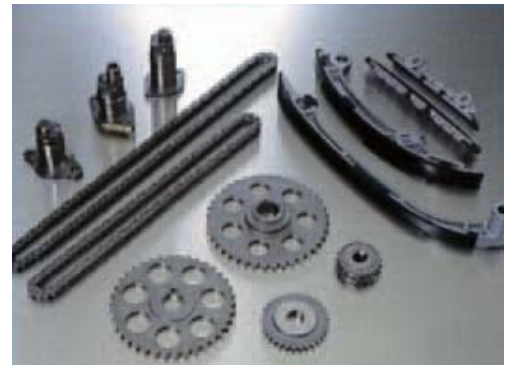
RF06E-U, RF05E-U - Special Simplex Chain

1. Pins have a specially hardened surface.
2. Bushing is extended from the inner link plate to increase the bearing area and reduce side bow of the chain.
3. Link plates are thicker than standard to increase tensile strength.

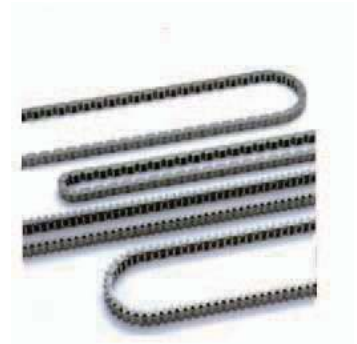
SILENT CHAIN

TSUBAKI'S Silent Chains are the fruit of efforts to further lower noise while maintaining roller-chain characteristics. Also, TSUBAKI has realized even more compact timing chain drive systems by introducing an ultra-small, 6.35mm-pitch silent chain.

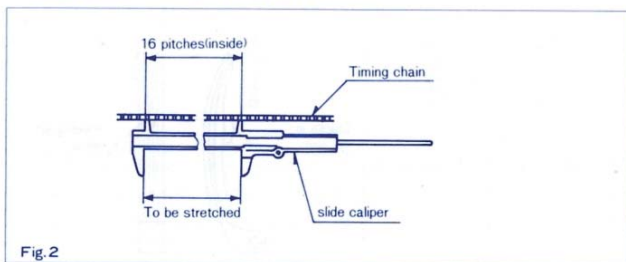
Fig.2

1. The chain becomes stiff against its articulation.
2. Abnormal wear or damage on bushing, roller, or link plate is observed.
3. When the average length measured over 16 pitches, at any of the 3 places shown in Fig.2, is over 146.6mm.

4. When the difference between max. length and min. length of above is over 0.15mm.

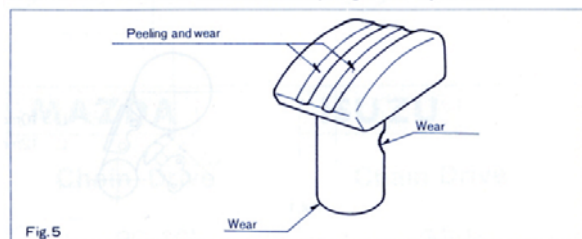
Fig.5

D) Replace the tensioner (Fig. 5) when:

1. Peeling or heavy scratches are observed on the rubber surface.
2. Wear amount over 0.5mm is observed on the rubber surface.
3. Abnormal wear is observed on the plunger rod (cylinder).

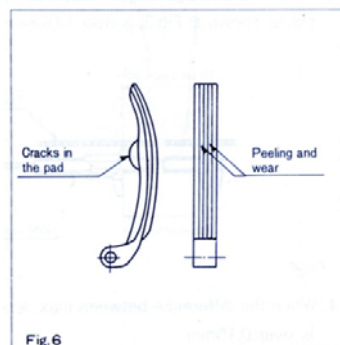
Fig.6

E) Replace the Guide Shoe (Fig. 6 & 7) when:

1. Any crack or peeling is observed on the rubber surface.
2. The wear amount exceeds 0.5mm on the rubber.
